✓
DOT/FAA/CT-88/03FAA Technical Center
Atlantic City International Airport
N.J. 08405

Study of Benefits of Passenger Protective Breathing Equipment From Analysis of Past Accidents

March 1988

Final Report

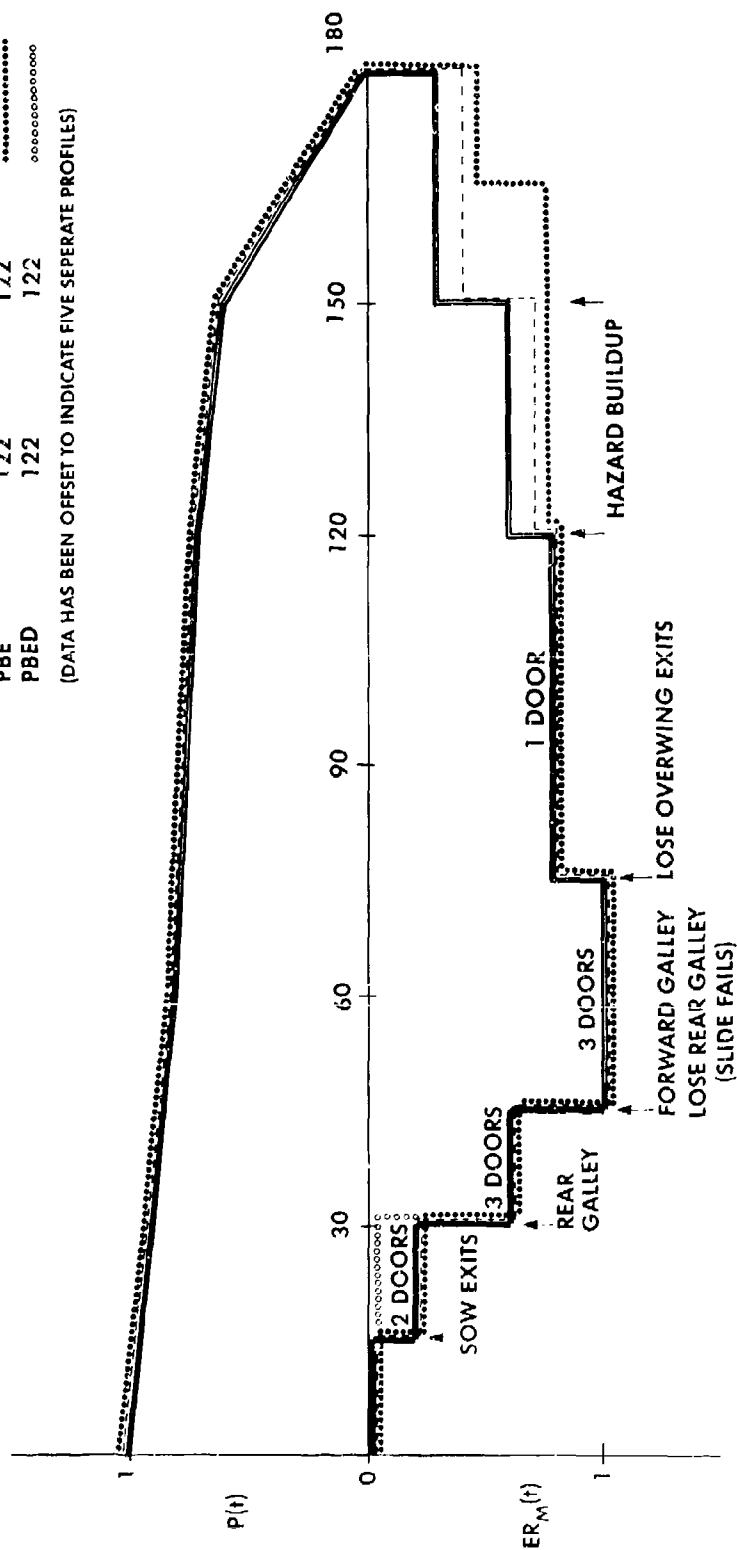
FIGURE 6. ACCIDENTS PROFILES FOR B-707 4/8/68

The evacuation was dominated by a spreading external fuel fire. The starboard overwing exits were first utilized (assume at 20 seconds). There were delays at the other exits due to problems preparing the slides for use (assume 30 and 45 seconds). Explosions and spreading fire under the rear of the fuselage resulted in the failure of the escape chute at the rear galley door and rendered the overwing escape route unusable. It was assumed the rear galley exit was unusable at 45 seconds, as only 10 passengers and one steward escaped from this exit. It was assumed the chief steward stopped usage of the starboard overwing exits at 75 seconds, as only 18 passengers escaped by these exits. The main body of the passengers and cabin crew evacuated from the forward galley exit. It was assumed the aircraft was unsurvivable at 180 seconds. No benefit was assigned for FB. A small benefit was assigned for FPL and PBE.

EVACUATION RATE = 1.548 PEOPLE/SECOND

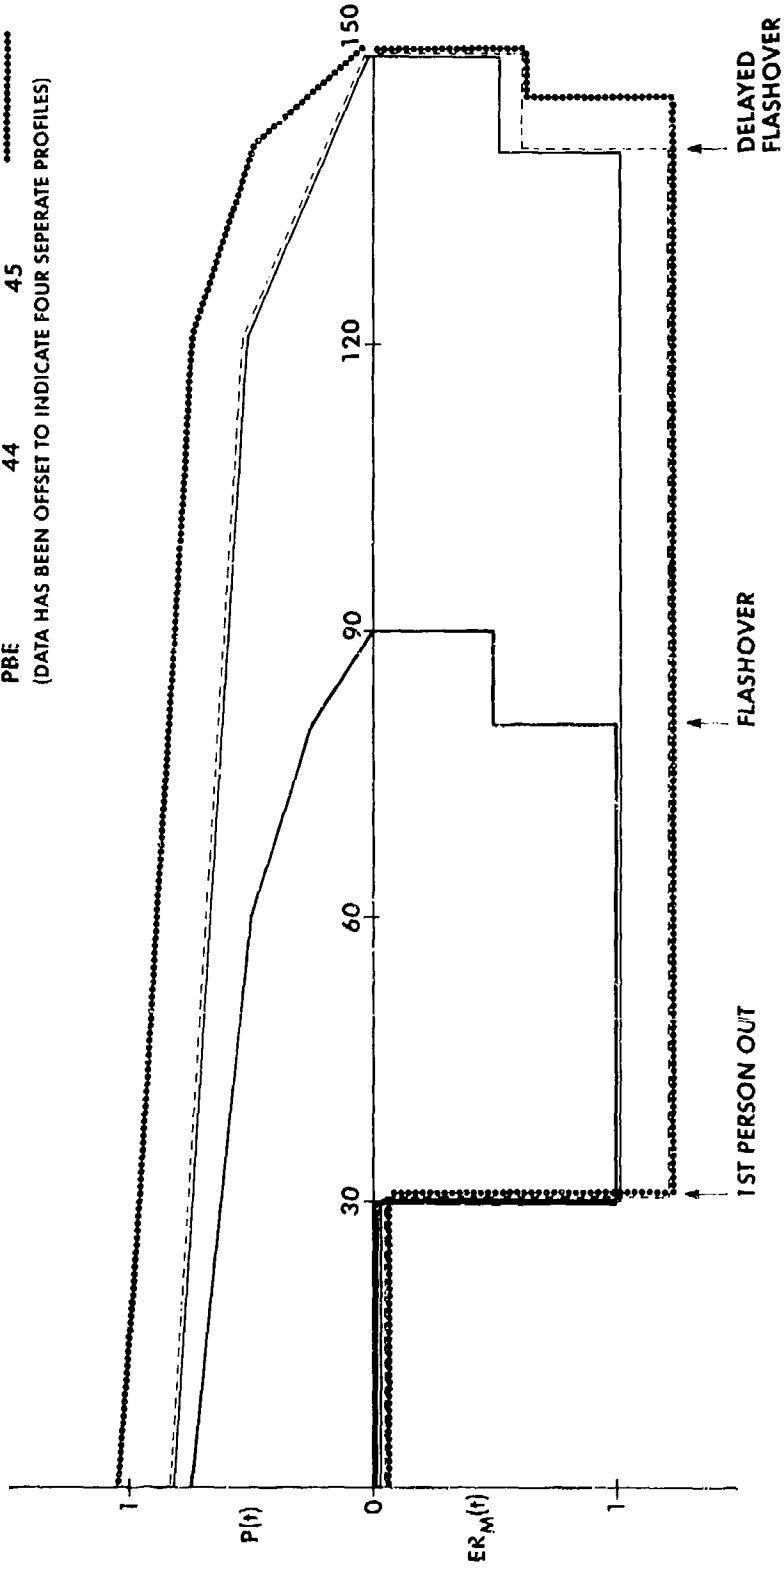
FIGURE 19. ACCIDENT PROFILES FOR AIR CANADA DC-9 6/2/83

The inflight fire originated behind the wall of the rear lavatory. The passengers in the rear moved into seats in the forward section while in flight. A thermal and toxic hazard level of 0.75 was assumed as the plane stopped. By this time, the smoke had built up such that people seated could not see their hands in front of their face. It was assumed the first person exited 20 seconds after the aircraft stopped. The NTSB report states the cabin burst into flames as the last person exited R2 at 60 to 90 seconds after the plane stopped. It was assumed the last person egressed at 90 seconds. Five of seven passenger exits were used. The aft rows of seats were probably involved. This hastened the onset of flashover. A 1-minute FB benefit was assigned. The FPL benefit would be immediate. A substantial PBE benefit was assigned because most deaths were from smoke inhalation and toxic gas. The thermal and toxic hazard level was increased with PBE to 1 at time 0 and then gradually decreased due to the buildup of other hazards (heat then fire).

IMPROVEMENT	PASSENGERS	SURVIVORS
NONE	117	117
FB	117	117
FPL	117	117
PBE	117	117
PBED	117	117

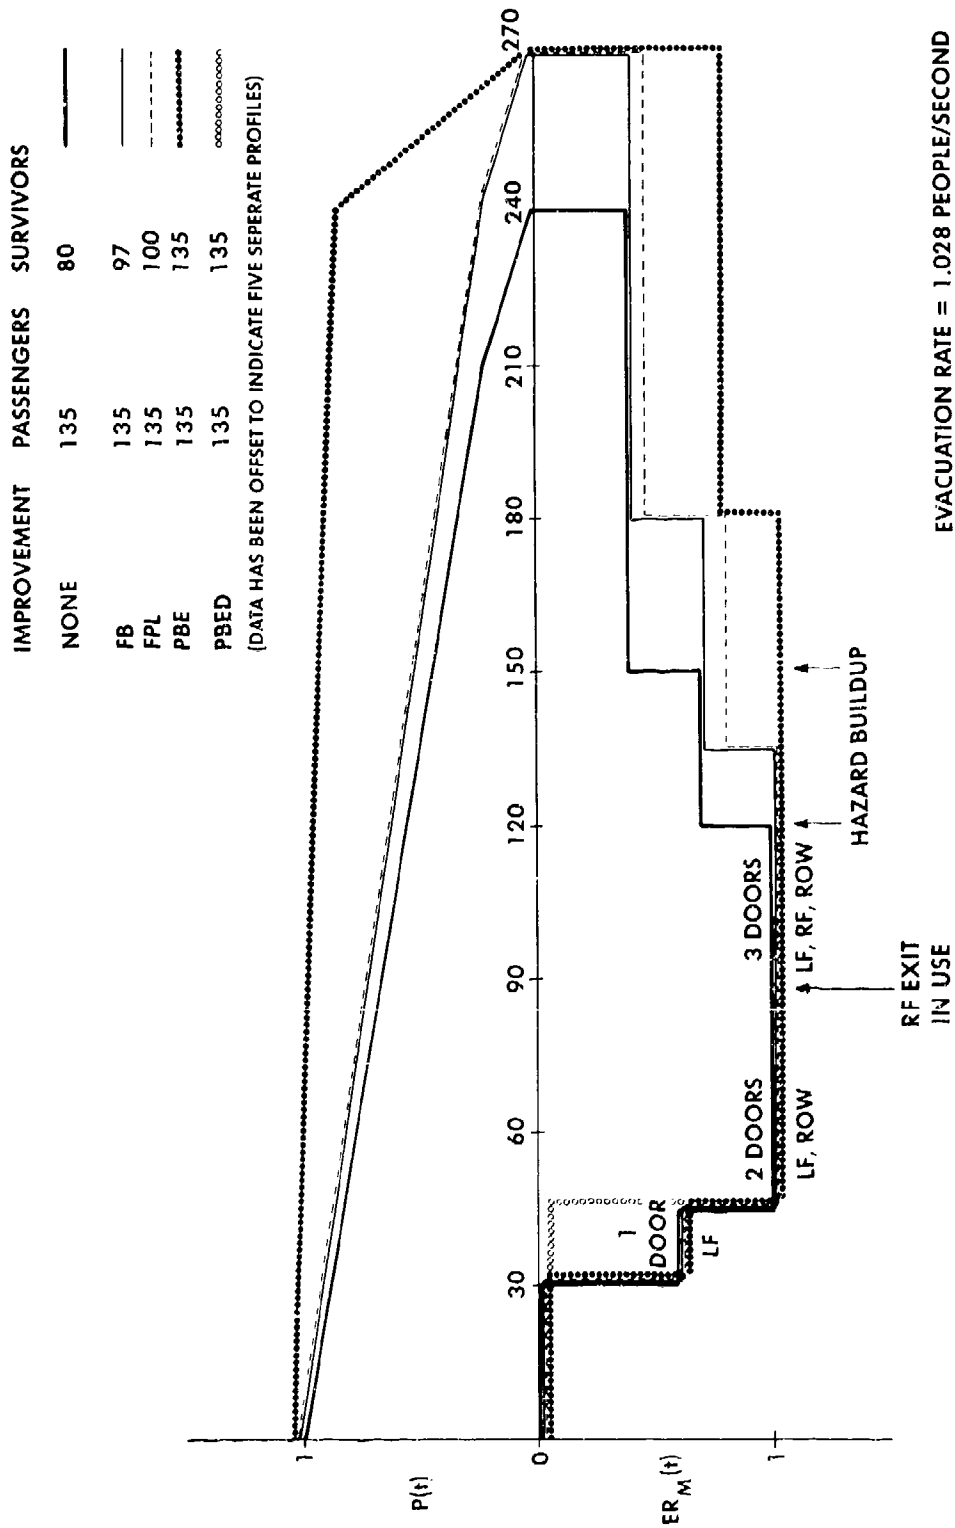
FIGURE 21. ACCIDENT PROFILES FOR BRITISH AIR TOURS B-737 8/22/85

The port engine and wing caught fire. Upon turning, the fire spread under the fuselage because of wind and totally engulfed the aft fuselage. Smoke initially entered the cabin through the melted aft/port windows just before the aircraft stopped. The first people were out of the left front door 30 seconds from stopping, and out of the right front door at 90 seconds. Passengers stopped using the LF when RF opened. The overwing exit was opened 45 seconds from stopping. Three and one-half to 4 minutes after stopping, all survivors (except one found inside by firemen 5 1/2 minutes after their arrival) were off the aircraft. It was assumed the plane was unsurvivable at 4 minutes. One eventual fatality was taken off the aircraft alive 33 minutes after the aircraft stopped. Sixteen egressed from LF, 35 from RF, and 24 from ROW. A 30-second benefit for FB was assumed, and FPL was assigned a later benefit due to bottlenecks forming at the exits. Passengers were falling down in the aisles. It is believed that PBE would greatly increase survivability, thus extending the evacuation, before the onset of flashover. There is no disbenefit with a 15-second donning delay in this model. The analysts relied on the British accounts of this accident. The profiles for this accident were modified based on discussions with the British due to their more immediate familiarity with this accident.
